New Complication Associated With All-Inside Meniscal Repair Device: Ultrasound-Aided Diagnosis and Operative Localization of Foreign Body Reaction

The Orthopaedic Journal of Sports Medicine, 4(9) <https://doi.org/10.1177/2325967116664882>

Study Design: Case series; Level of evidence, 4.

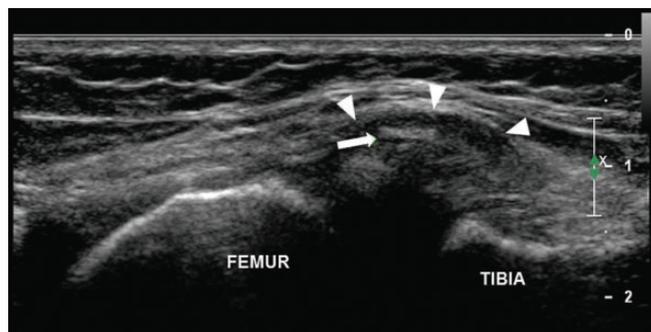
Ultrasound evaluation demonstrated nonabsorbable meniscal suture material located just posterior to the medial collateral ligament (MCL) and anterior to the semimembranosus tendon (Figure 1). Adventitial bursal tissue surrounded the suture material, and there was reproduction of typical pain symptoms with direct sonopalpation including a positive Tinel sign in a saphenous distribution. While no discrete saphenous neuroma was identified, a branch of the nerve appeared to course in the region of the bursal tissue. Diagnostic injection of local anesthetic infiltrated under live sonographic guidance resulted in complete resolution of pain and restoration of normal gait. After discussing treatment options with the patient, including corticosteroid injection versus surgical excision of the foreign body reaction and saphenous neurolysis with intraoperative ultrasound guidance, the patient elected to proceed with the more definitive treatment option given the chronicity of her symptoms.

Figure 1. Case 1. Long-axis sonogram over the posteromedial knee, just anterior to the semimembranosus tendon. Arrow demonstrates hyperechoic meniscal suture material. The surrounding hypoechoic tissue (arrowheads) represents inflammatory tissue reaction/adventitial bursa.

Intraoperatively, ultrasound was used to identify the foreign body and surrounding reactive tissue, and an 18-gauge spinal needle was guided to the suture material. An approximately 2-cm longitudinal incision centered at the 18-gauge needle was then made, followed by blunt

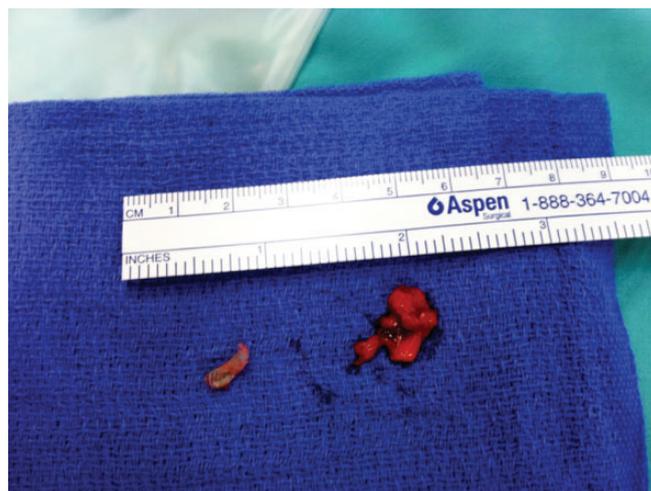
Figure 2. Case 1. Intraoperative photograph. Resected suture material on left and inflammatory bursal tissue on right.

dissection to the posterior aspect of the superficial MCL. Suture material reaction as well as a piece of the all-inside device that was covered in reactive tissue was excised (Figure 2).

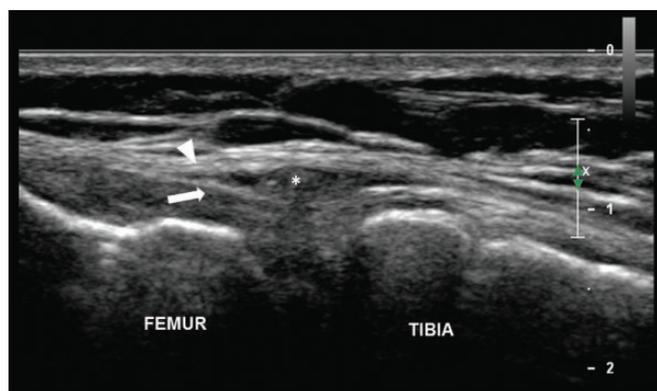
Figure 3. Case 2. Long-axis sonogram over the medial joint line. Inflammatory bursitis associated with meniscal suture material (asterisk) is seen lying between the superficial (arrowhead) and deep (arrow) layers of the medial collateral ligament.

Ultrasound evaluation demonstrated hypoechoic tissue between the superficial and deep layers of the MCL, with nonabsorbable suture material at the center of this reactive bursa (Figure 3). Diagnostic injection (Figure 4) of local anesthetic and corticosteroid infiltrated under live sonographic guidance resulted in complete resolution of symptoms immediately postinjection, but the injection provided no lasting benefit beyond the local anesthesia. Thus, it was decided to proceed with surgical excision.

Intraoperatively, a similar technique was used to that described in case 1 to identify, mark, and excise the offending retained suture anchor and surrounding reactive tissue. Minimal medial compartment chondromalacia was appreciated, and the medial meniscus was felt to be healed from previous repair with probing.

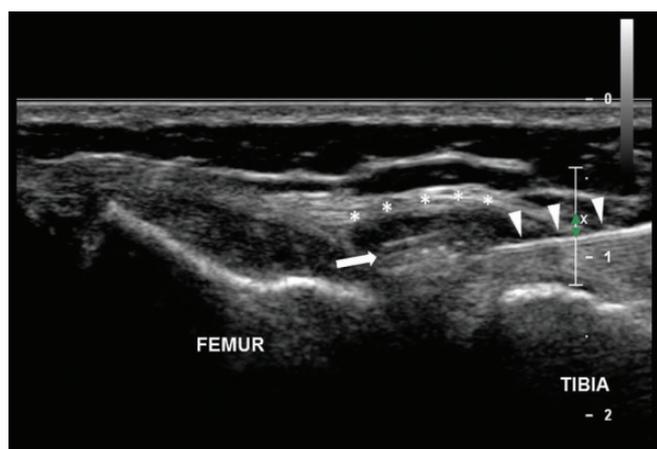
Figure 4. Case 2. Long-axis sonogram over the medial joint line. A 27-gauge (30-mm) needle (arrowheads) is used to infiltrate the bursa (asterisks) with 1% lidocaine for diagnostic purposes. The meniscal suture (arrow) is better visualized with surrounding hypoechoic injectate.

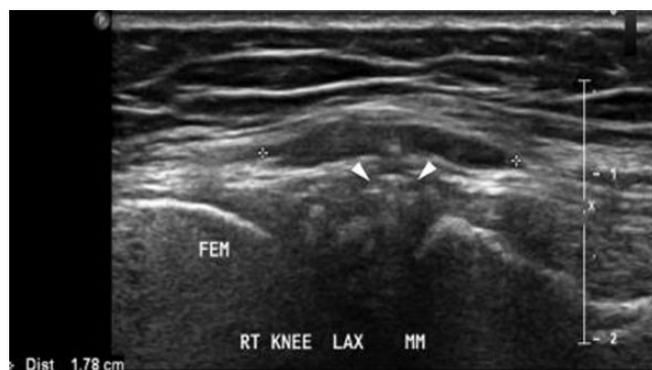
Figure 5. Case 3. Long-axis sonogram over the medial joint line demonstrating a “proud” suture anchor extending beyond the border of the medial meniscus (arrowheads) into the superficial medial collateral ligament with a resultant adventitial bursa (between calipers).

Subsequent sonographic evaluation demonstrated a proud suture anchor extending beyond the periphery of the

meniscus into the region of the MCL, resulting in an adventitial bursa (Figure 5), as well as migration of a suture fragment into the medial subcutaneous tissue (Figure 6). Sonopalpation confirmed that the maximal area of tenderness was directly over the adventitial bursa.

A repeat diagnostic arthroscopy was performed, and the meniscus was felt to be healed and stable to probing. No additional abnormalities were identified. A 2-cm medial incision was made over the previously marked point of maximal tenderness. An adventitial bursa as well as 3 suture anchors (2 still connected to the suture) were identified along the posterior border of the MCL. The bursa and foreign material were excised. At 6-week follow-up, the patient's symptoms had completely resolved. She had minimal tenderness to palpation, full range of motion, and was able to resume full activity with no restrictions. She was discharged to follow-up as needed with no further complaints 2 years after surgery.

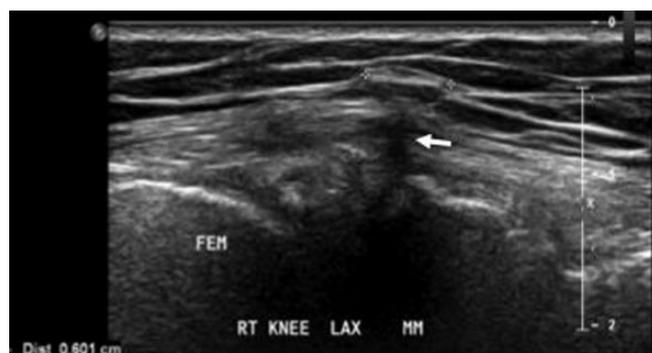
Figure 6. Case 3. Long-axis sonogram over the medial joint line demonstrating a suture fragment that has migrated into the subcutaneous tissue (between calipers). Note the hypoechoic migration path of the suture fragment (arrow).
