New Complication Associated With All-Inside Meniscal Repair Device: Ultrasound-Aided Diagnosis and Operative Localization of Foreign Body Reaction

New Complication Associated With All-Inside Meniscal Repair Device

Ultrasound-Aided Diagnosis and Operative Localization of Foreign Body Reaction

Study Design: Case series; Level of evidence, 4.

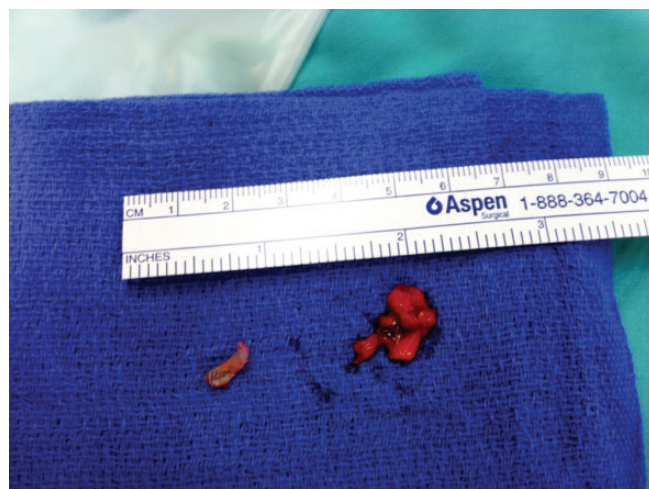
Figure 2. Case 1. Intraoperative photograph. Resected suture material on left and inflammatory bursal tissue on right.

dissection to the posterior aspect of the superficial MCL. Suture material reaction as well as a piece of the all-inside device that was covered in reactive tissue was excised (Figure 2).

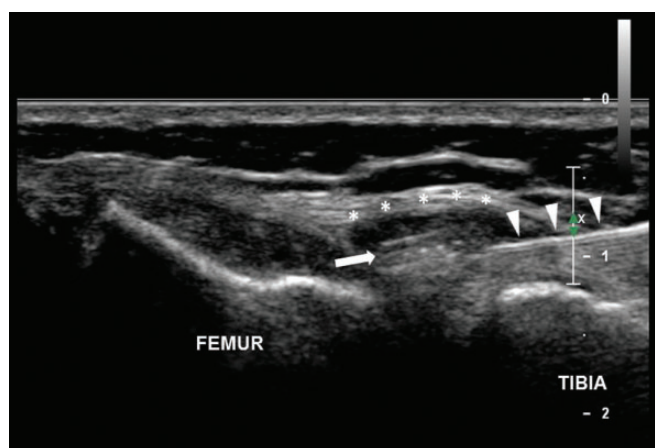
Figure 4. Case 2. Long-axis sonogram over the medial joint line. A 27-gauge (30-mm) needle (arrowheads) is used to infiltrate the bursa (asterisks) with 1% lidocaine for diagnostic purposes. The meniscal suture (arrow) is better visualized with surrounding hypoechoic injectate.

Ultrasound evaluation demonstrated hypoechoic tissue between the superficial and deep layers of the MCL, with nonabsorbable suture material at the center of this reactive bursa (Figure 3). Diagnostic injection (Figure 4) of local anesthetic and corticosteroid infiltrated under live sonographic guidance resulted in complete resolution of symptoms immediately postinjection, but the injection provided no lasting benefit beyond the local anesthesia. Thus, it was decided to proceed with surgical excision.

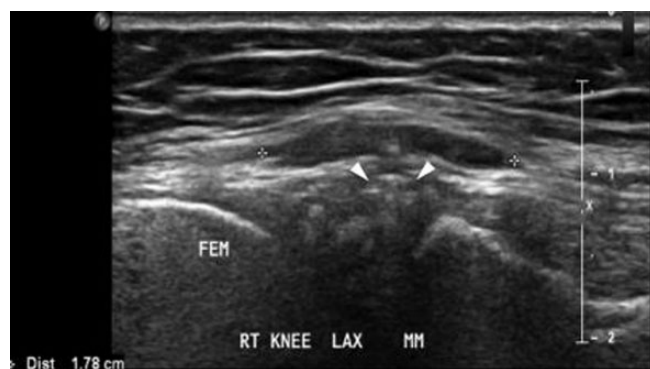
Figure 5. Case 3. Long-axis sonogram over the medial joint line demonstrating a “proud” suture anchor extending beyond the border of the medial meniscus (arrowheads) into the superficial medial collateral ligament with a resultant adventitial bursa (between calipers).

Subsequent sonographic evaluation demonstrated a proud suture anchor extending beyond the periphery of the

meniscus into the region of the MCL, resulting in an adventitial bursa (Figure 5), as well as migration of a suture fragment into the medial subcutaneous tissue (Figure 6). Sonopalpation confirmed that the maximal area of tenderness was directly over the adventitial bursa.

A repeat diagnostic arthroscopy was performed, and the meniscus was felt to be healed and stable to probing. No additional abnormalities were identified. A 2-cm medial incision was made over the previously marked point of maximal tenderness. An adventitial bursa as well as 3 suture anchors (2 still connected to the suture) were identified along the posterior border of the MCL. The bursa and foreign material were excised. At 6-week follow-up, the patient's symptoms had completely resolved. She had minimal tenderness to palpation, full range of motion, and was able to resume full activity with no restrictions. She was discharged to follow-up as needed with no further complaints 2 years after surgery.

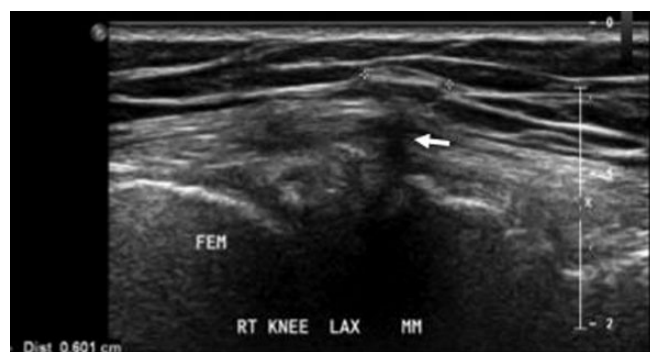
Figure 6. Case 3. Long-axis sonogram over the medial joint line demonstrating a suture fragment that has migrated into the subcutaneous tissue (between calipers). Note the hypoechoic migration path of the suture fragment (arrow).
